**Flood Control Project Maintenance
Levee Inspections**

2019 Channel Summary Report

Fairfield Suisun Sewer District

Levee Inspection Report By Mile - Channel 2019

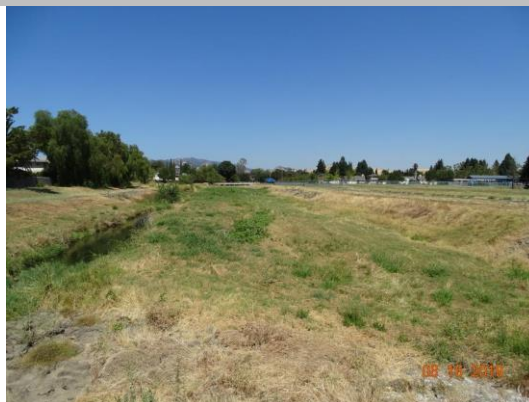
Photo 1 of 1 : CH_2019_NA0035_15_1_20190819_00103.jpg

Inspector Comments: Minimal scattered vegetation. The flow is not impeded.

View of the channel looking upstream. Summer 2019.

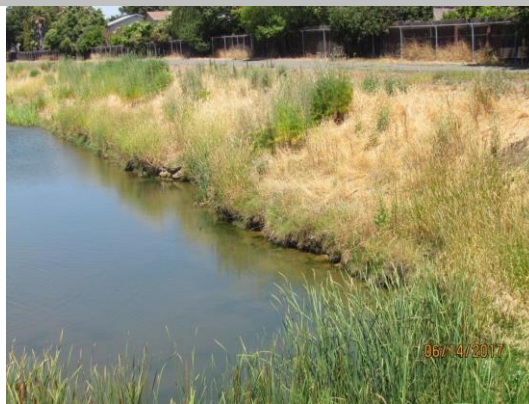
Photo 1 of 1 : CH_2019_NA0035_15_43_20190801_00043.jpg

Inspector Comments: Minimal erosion along channel banks that does not appear to be an issue at this time. Recommend monitoring.

View of minor erosion on left bank looking upstream. Summer 2017.

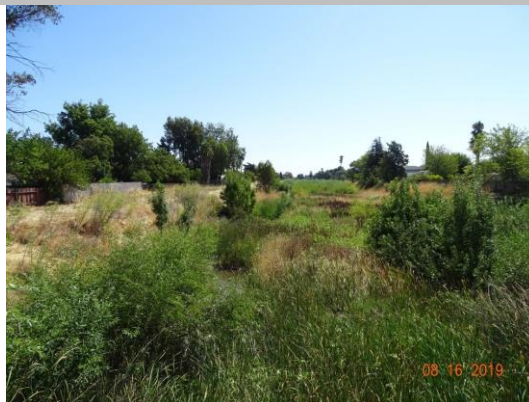
Photo 1 of 1 : CH_2019_NA0035_15_76_20190819_00089.jpg

Inspector Comments: Trash, debris, excavations, structures, or other obstructions present, or inappropriate activities that will not inhibit project operations and maintenance or emergency operations were observed.

View of the channel looking downstream. Summer 2019.

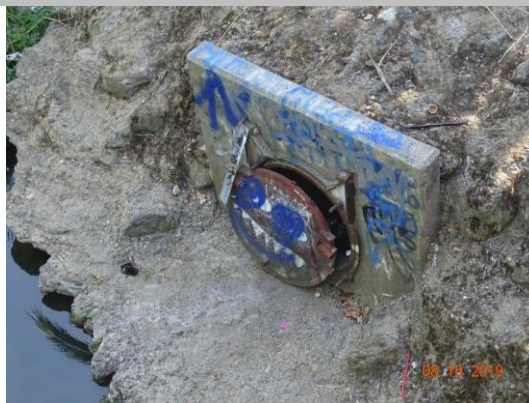
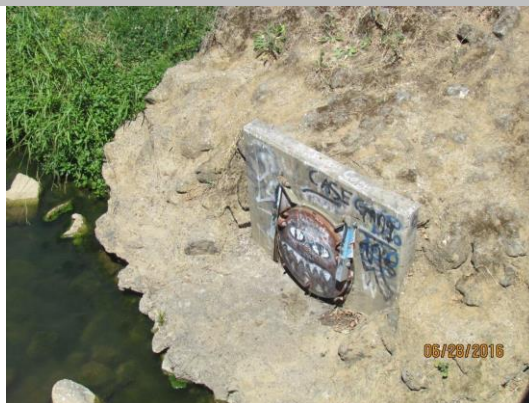
Inspector Comments: Flap gate on nearby drainage pipe is broken and should be repaired, but does not have an affect on the capacity of the channel.

View of the flapgate located on the upstream side of Rockville Road. Summer 2019.

View of the flap gate located on the upstream side of Rockville Rd. Summer 2016.

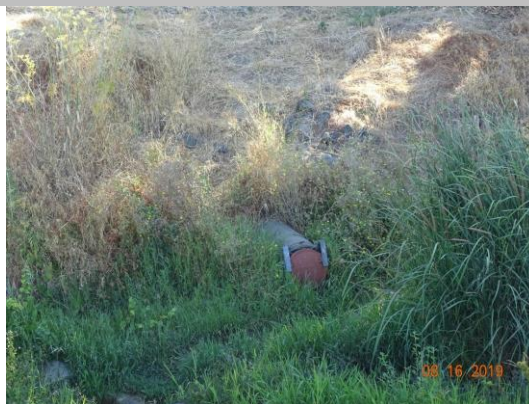
Photo 1 of 1 : CH_2019_NA0035_17_82_20190819_00081.jpg

Inspector Comments: Gates open and close easily with minimal leakage. Gates show no corrosion damage and have been maintained.

View of the gate on the downstream side of the channel from Auto Mall Pkwy. Summer 2019.

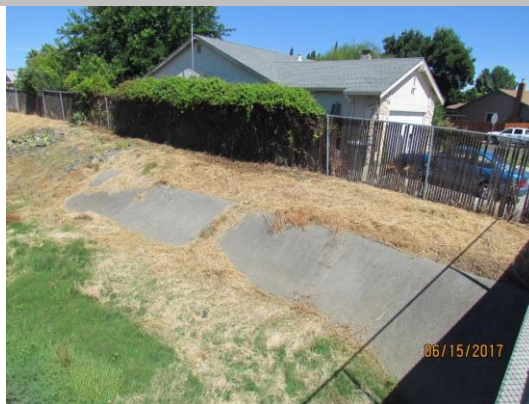
Photo 1 of 1 : CH_2019_NA0035_16_41_20190801_00029.jpg

Check Point / View				
Gulf Dr / Up (cont)				
Rating **	A	Issue No.	41	GPS Lat/Long
Issue Type +	Ma	Location *		38.281002 °
Category	Rivers, Channels & Designated Flood			-122.020570 °
Item	Concrete Surfaces			
DWR ID	DWR_NA0035_16_c_2017_41			
Action/Comments				
Inspector Comments: Concrete surface appears to be in good condition with no visible deficiencies.

View of concrete surface on left bank, looking upstream. Summer 2017.
